FRASER BASIN COUNCIL

THOMPSON RIVER WATERSHED GEOHAZARD RISK PRIORITIZATION

FINAL
March 31, 2019

BGC Project No.:
0511002

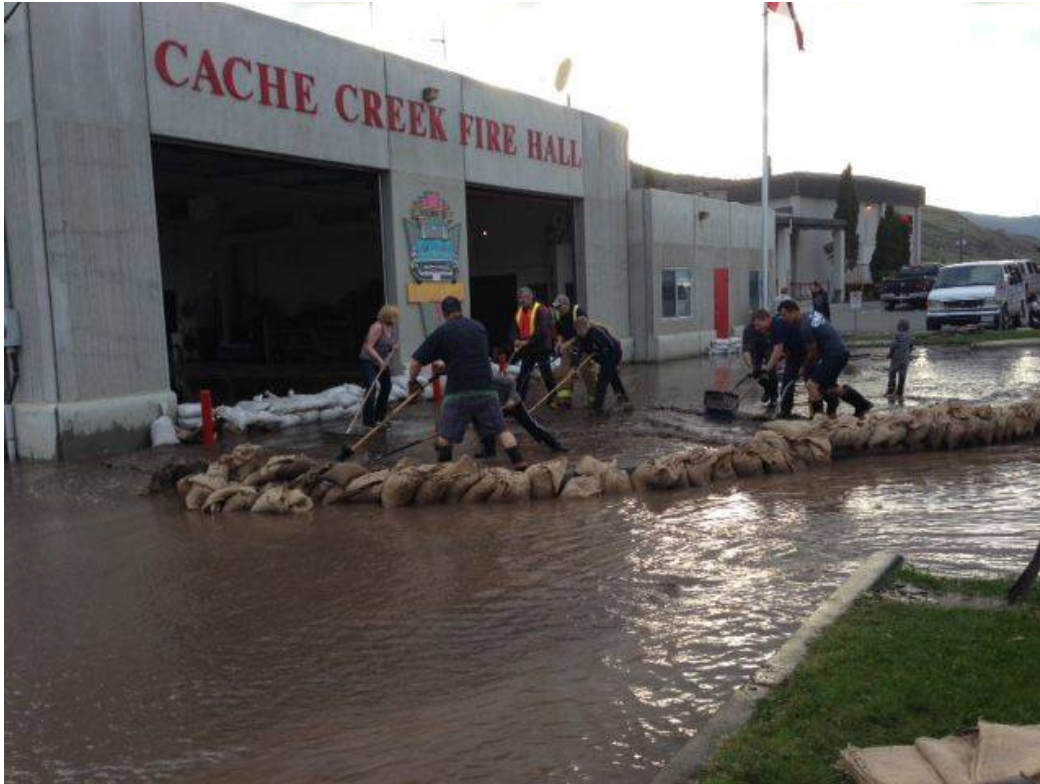
Figure 1-2. Preventative sandbagging in May 2017 near the Cache Creek Fire Hall (Global News, May 5, 2017).

- Debris floods at Sicamous and Hummingbird Creeks in June 2012, which caused damage to several houses at Swansea Point and Two Mile. The debris flood at Sicamous Creek is the subject of a lawsuit currently before the courts
- Flooding in Cache Creek in 2015, 2017 (Figure 1-2), and 2018, which includes the flood-related fatality of the Cache Creek fire chief in 2017
- Flooding in Cherry Creek south of Kamloops BC in 2017 and 2018 (Figure 1-4)
- Robinson Creek debris flow, near Paradise Point, in May 2017, which led to one fatality and destroyed at least two houses (Figure 1-5)
- Debris flows in July and August 2018 that blocked Highways 1 and 97 in more than 40 places between Ashcroft and Clinton, BC (Figure 1-5). The debris flows were sourced from areas burnt by the 2017 Elephant Hill wildfire. The debris flows caused one fatality and several houses were affected by debris.

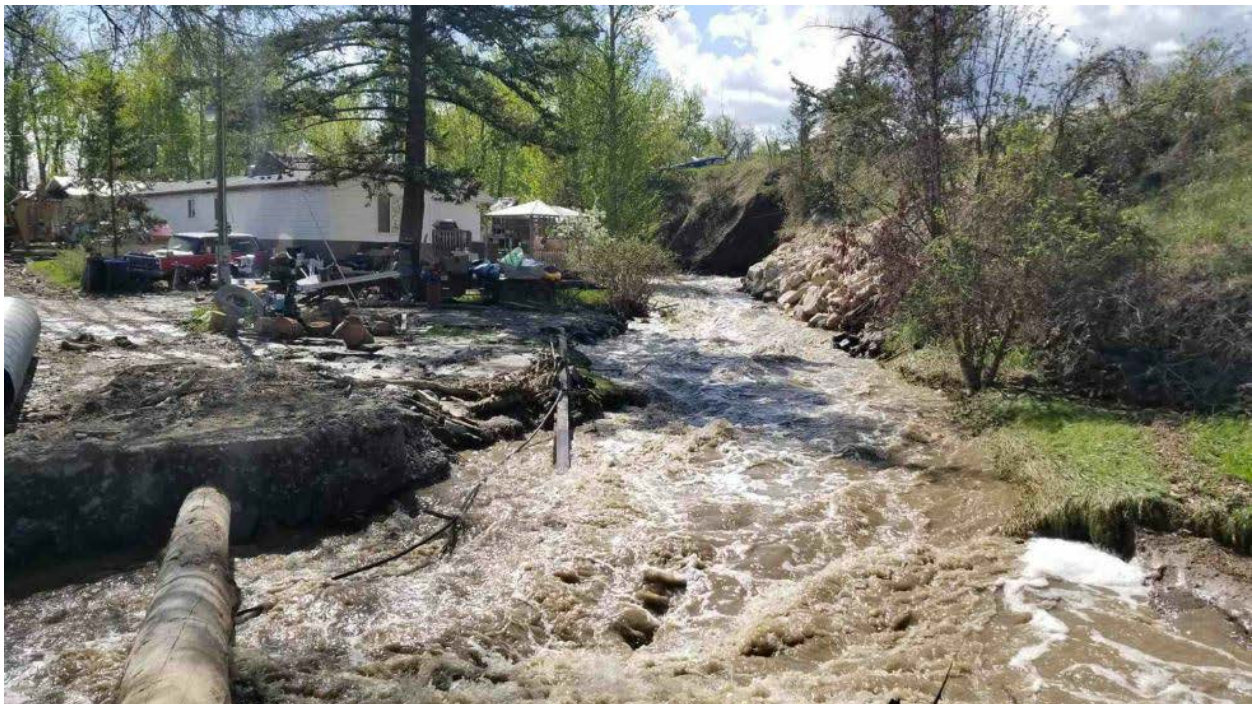
Figure 1-3. Damage from flooding in Cherry Creek in May 2018 (CJFC Today, May 7, 2018).

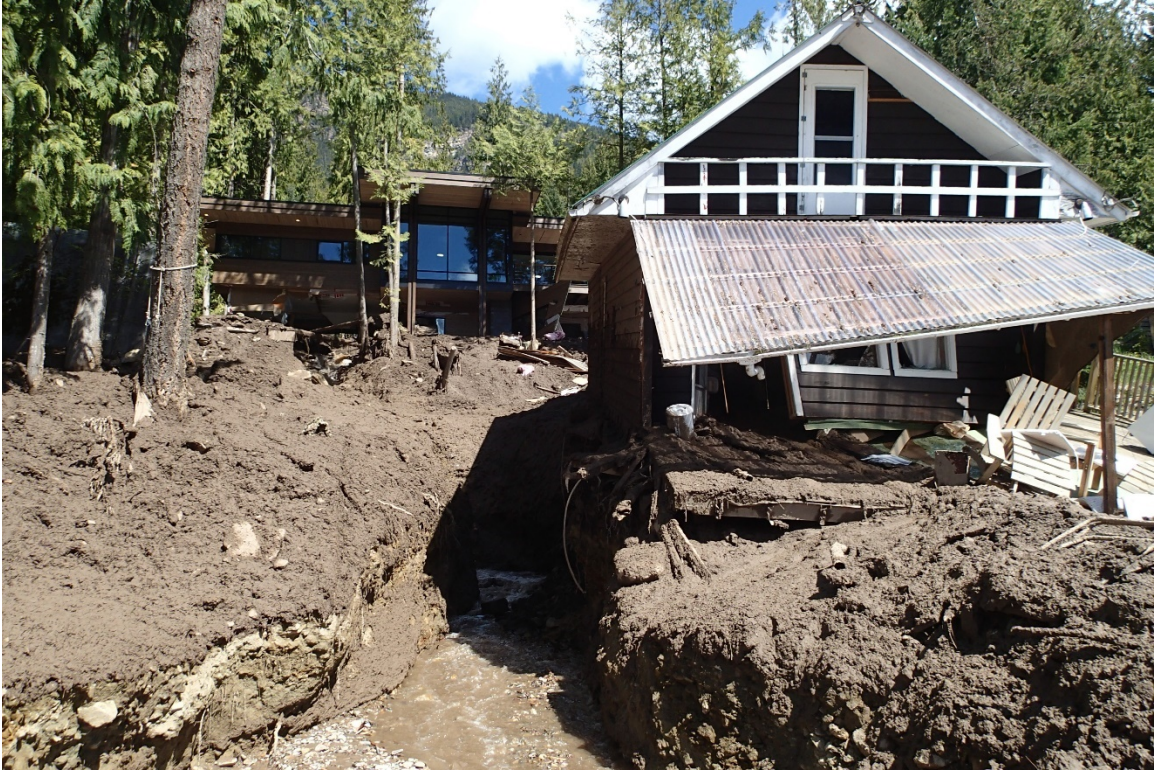
Figure 1-4. Damaged buildings from the 2017 Robinson Creek debris flow. Photo: BGC, May 7, 2017.

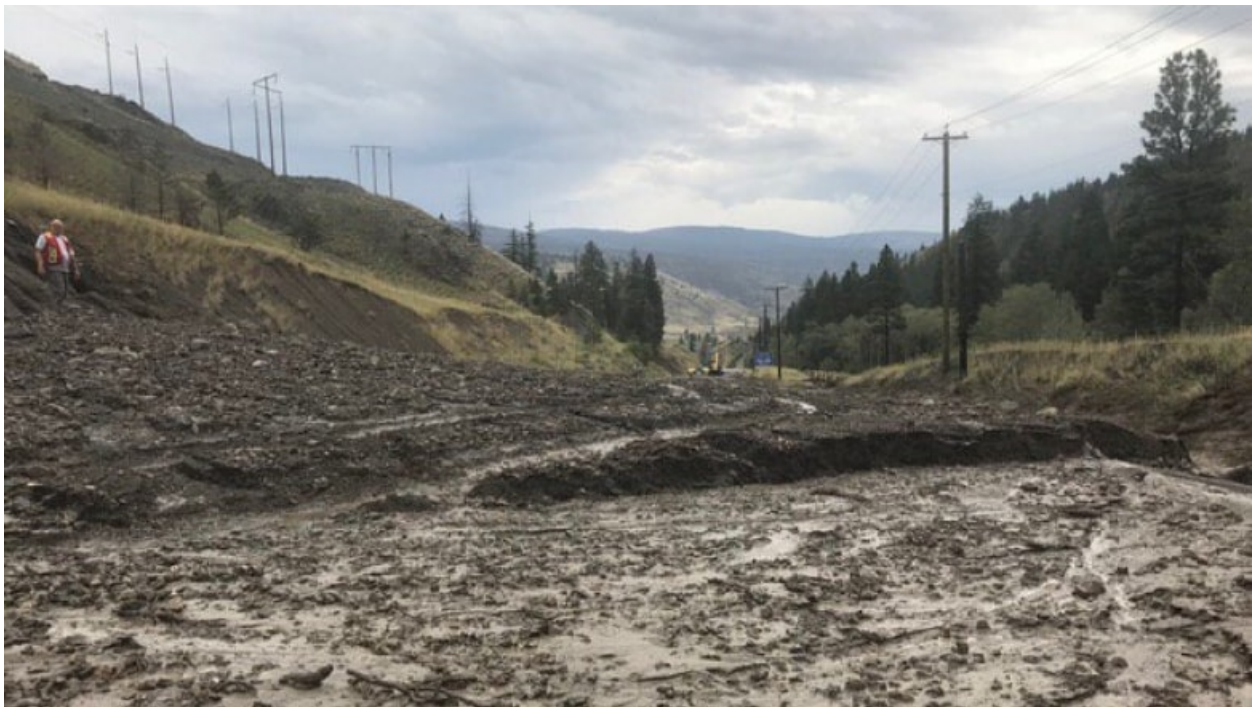
Figure 1-5. Debris flow blocking Highway 97 south of Clinton, BC on July 31, 2018 (MOTI, 2018). This area was burned in 2017 by the Elephant Hill Wildfire.

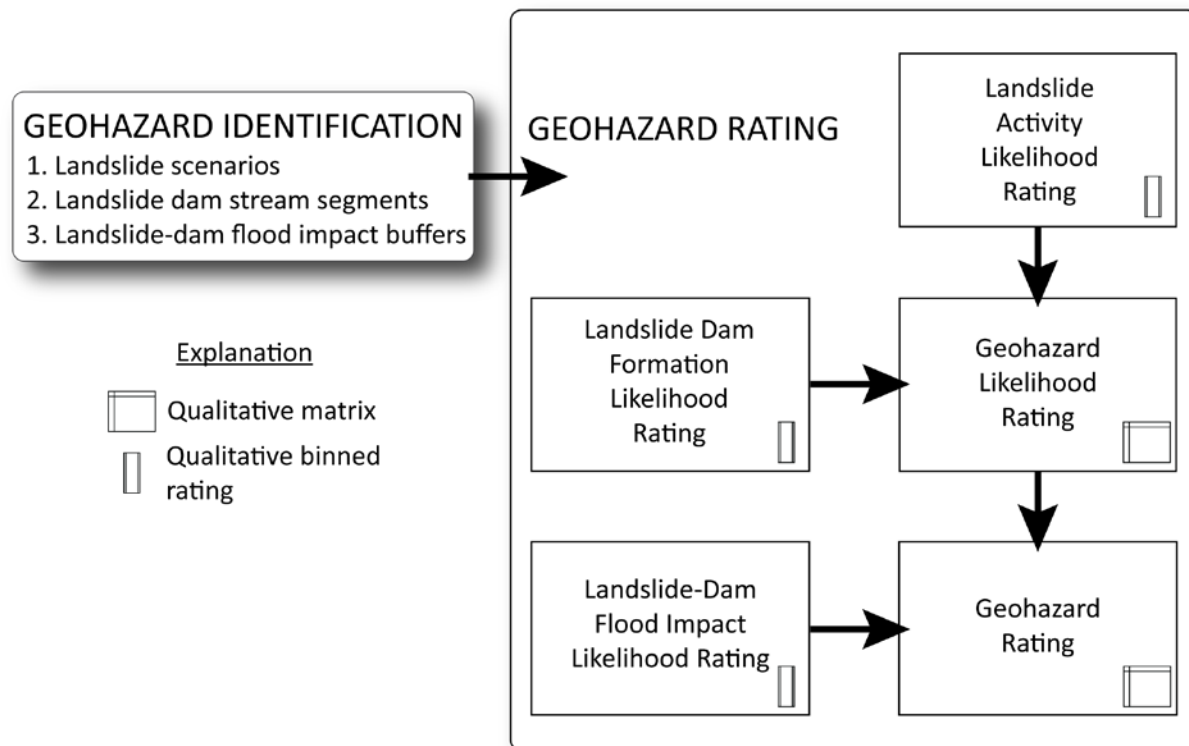
Figure 4-5. Workflow and key elements of the landslide-dam flood geohazard identification and geohazard ranking process.

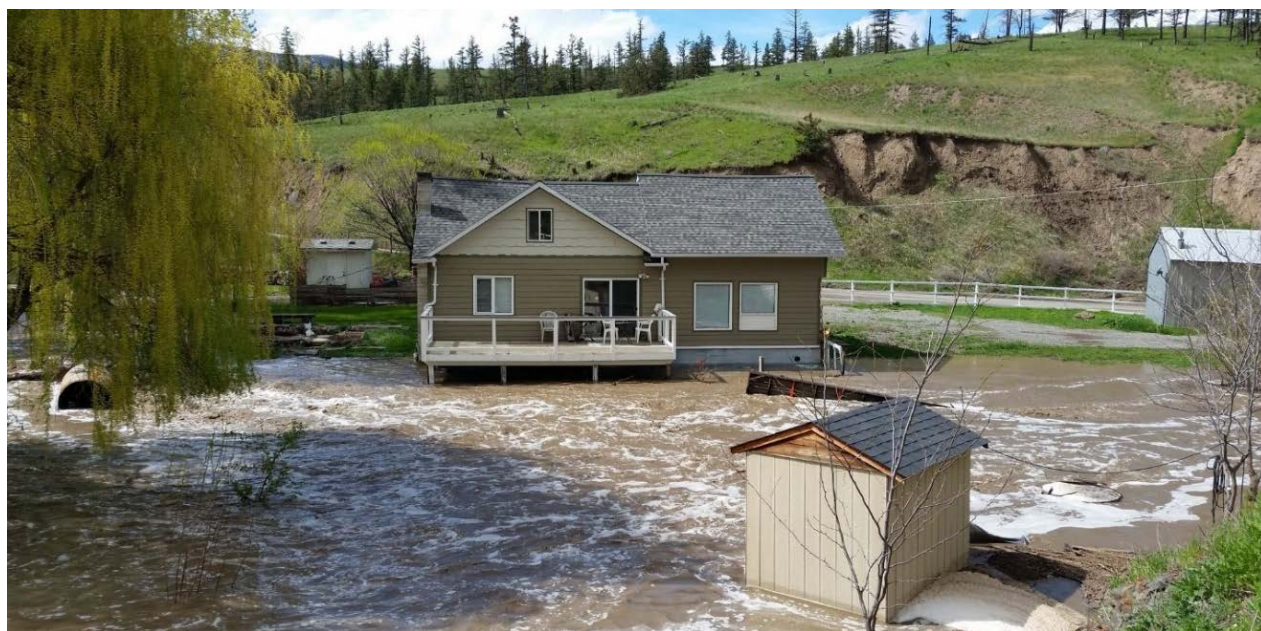
Figure B-1. Damage from flooding of Noble Creek in Kamloops, BC (CFJC Today, May 5, 2017).

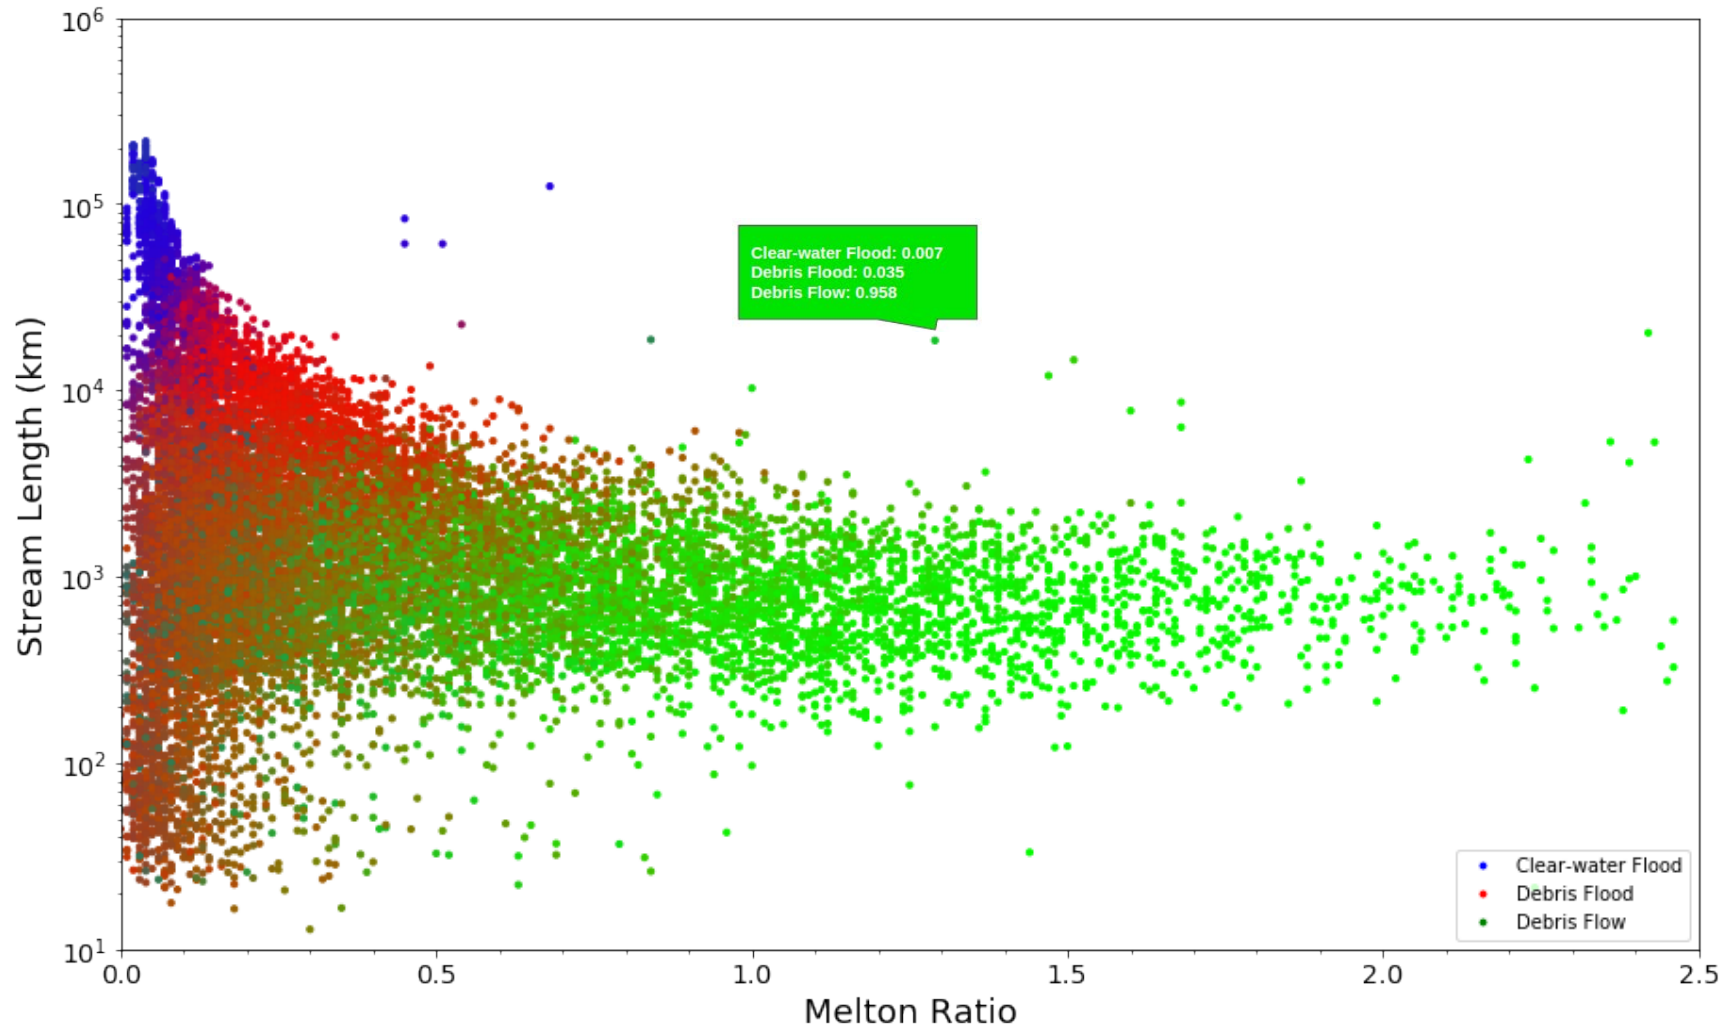
Figure B-6. Geohazard process-types identified for a subset of the TRW stream segments based on stream length (km) and Melton Ratio. Probabilities associated with the identified process type are shown for one predicted debris flow site.

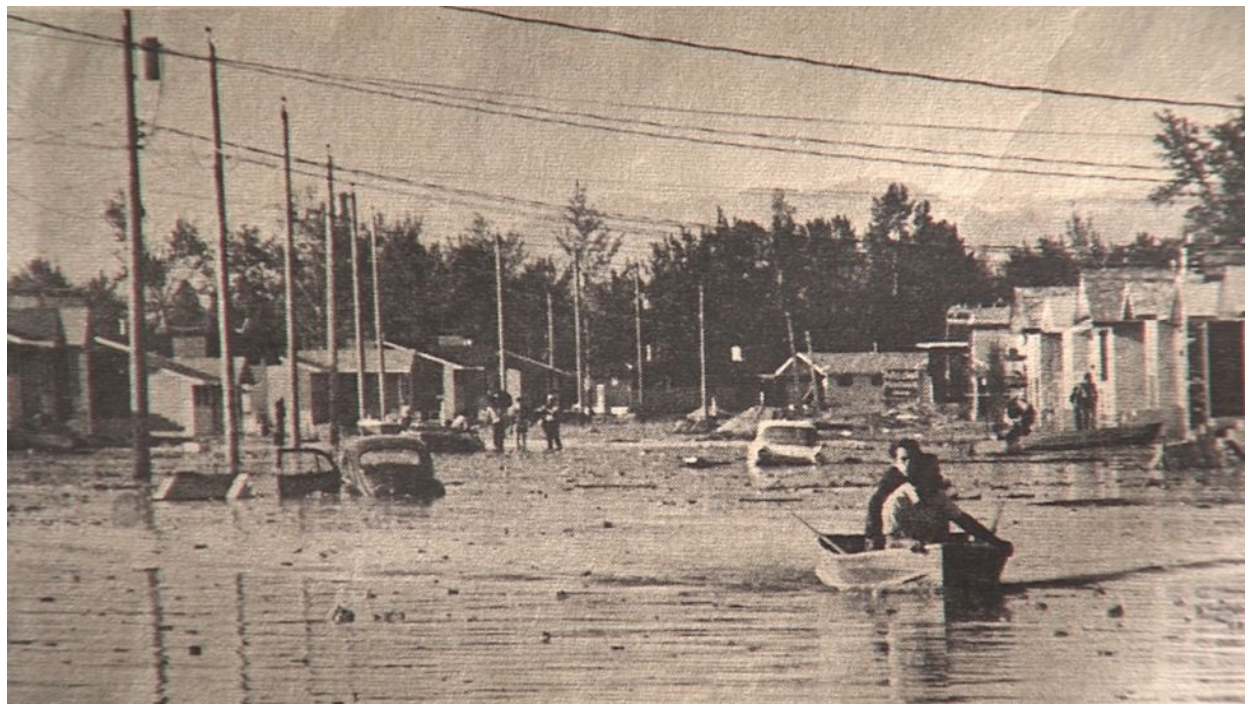
Figure B-7. Flood event of June 2, 1972 when dikes along the North Thompson River failed and sent flood water into the Oak Dale Trailer Park in Westsyde, near Kamloops BC. (CFJC Today, June 2, 2017).

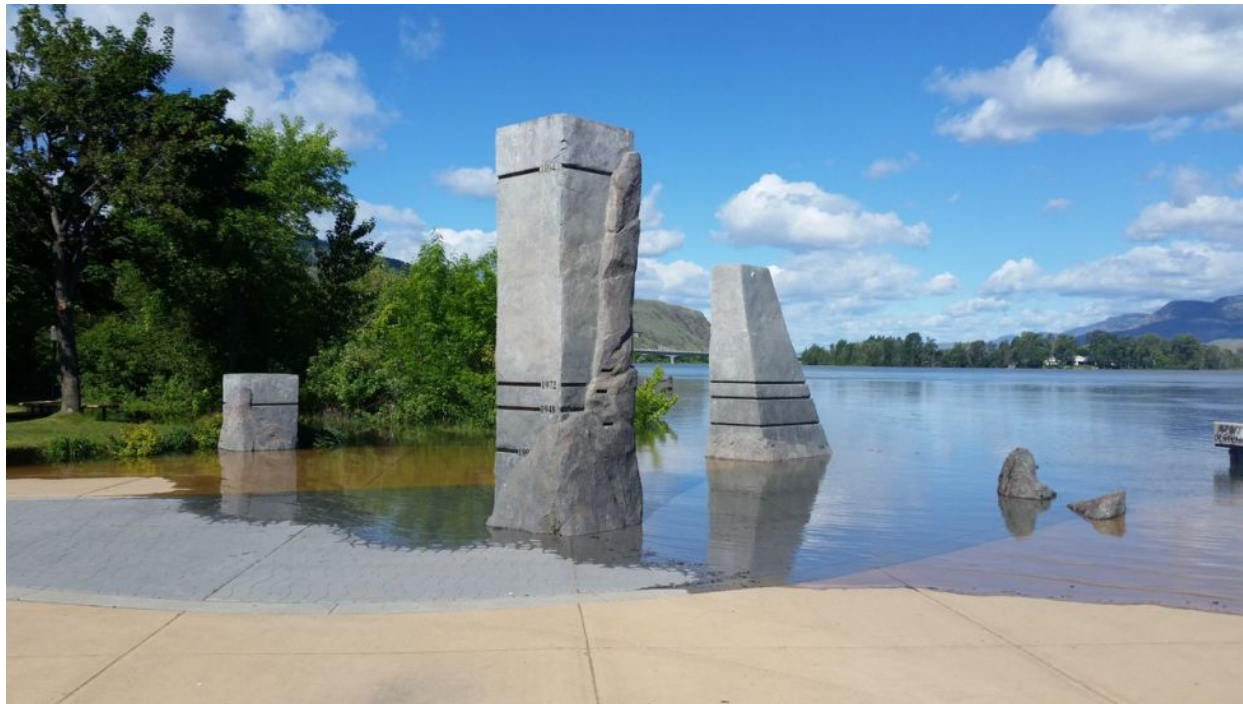
A vertical column located in Riverside Park's High Water Plaza adjacent to the banks of the South Thompson River in Kamloops BC, provides a visual reminder of four past significant flood events; including the largest flood event on record in 1894. The four events from bottom to top on the column include 1999, 1948, 1972, and 1894 (Figure B-8).

Figure B-8. High water mark monuments adjacent to the South Thompson River in Kamloops BC. (CFJC Today, June 1, 2017).

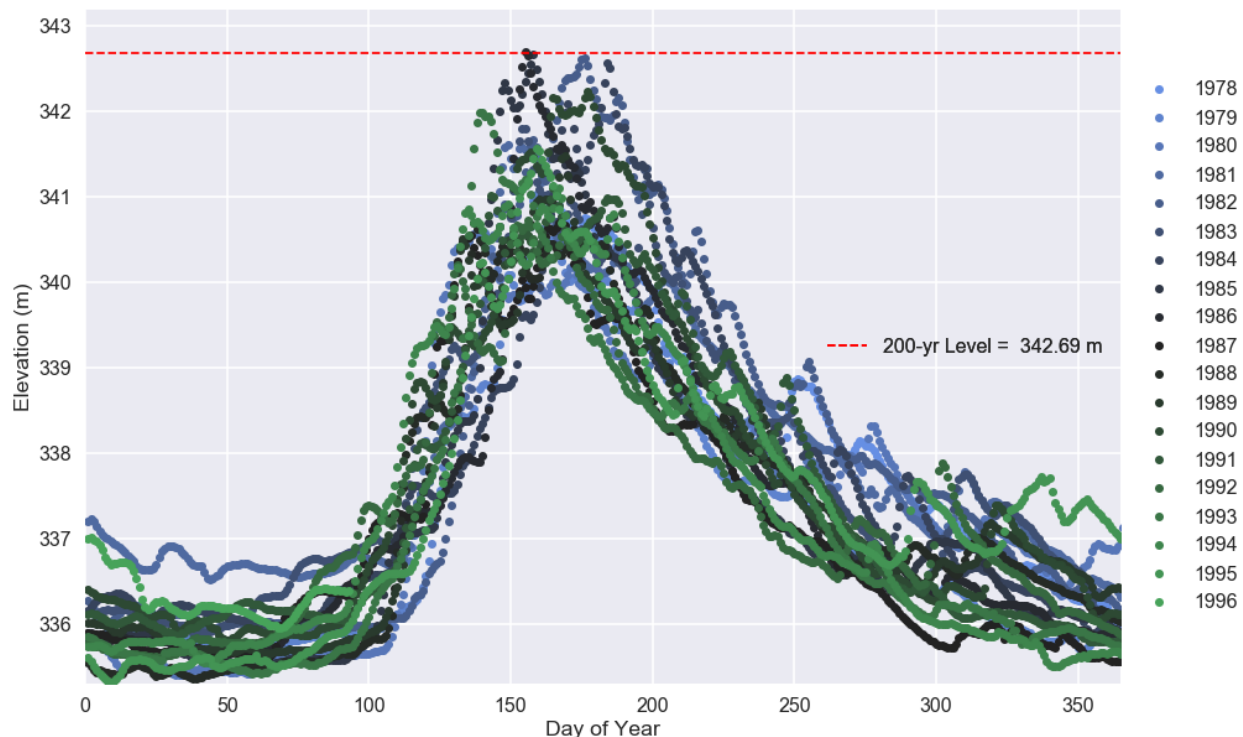
Figure B-15. Kamloops Lake near Kamloops (08LF085) historical lake levels.

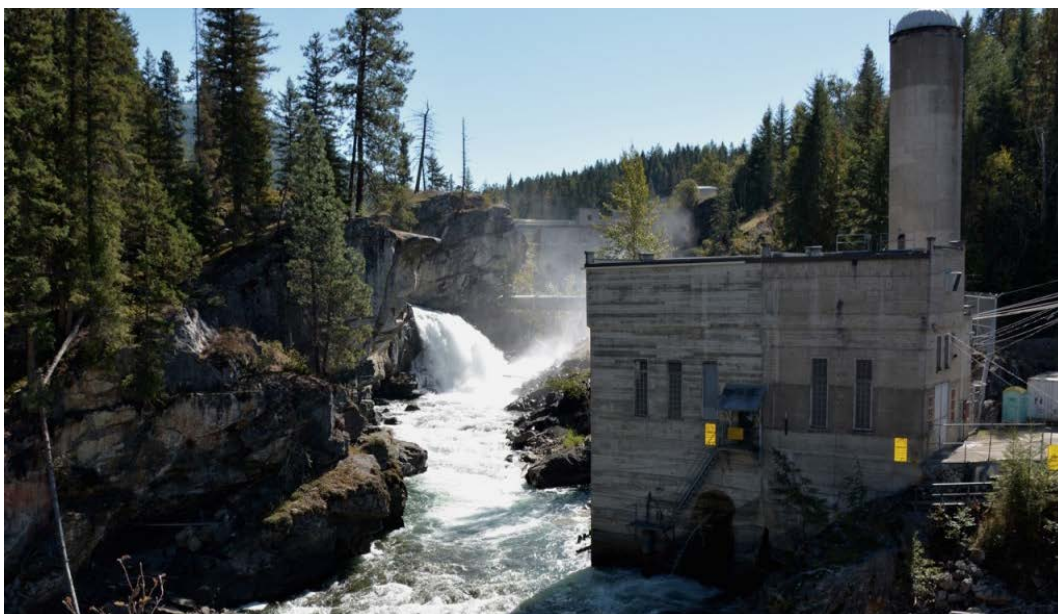
Figure B-19. Wilsey Dam on the Shuswap River near Lumby (Vernon News, July 3, 2018).

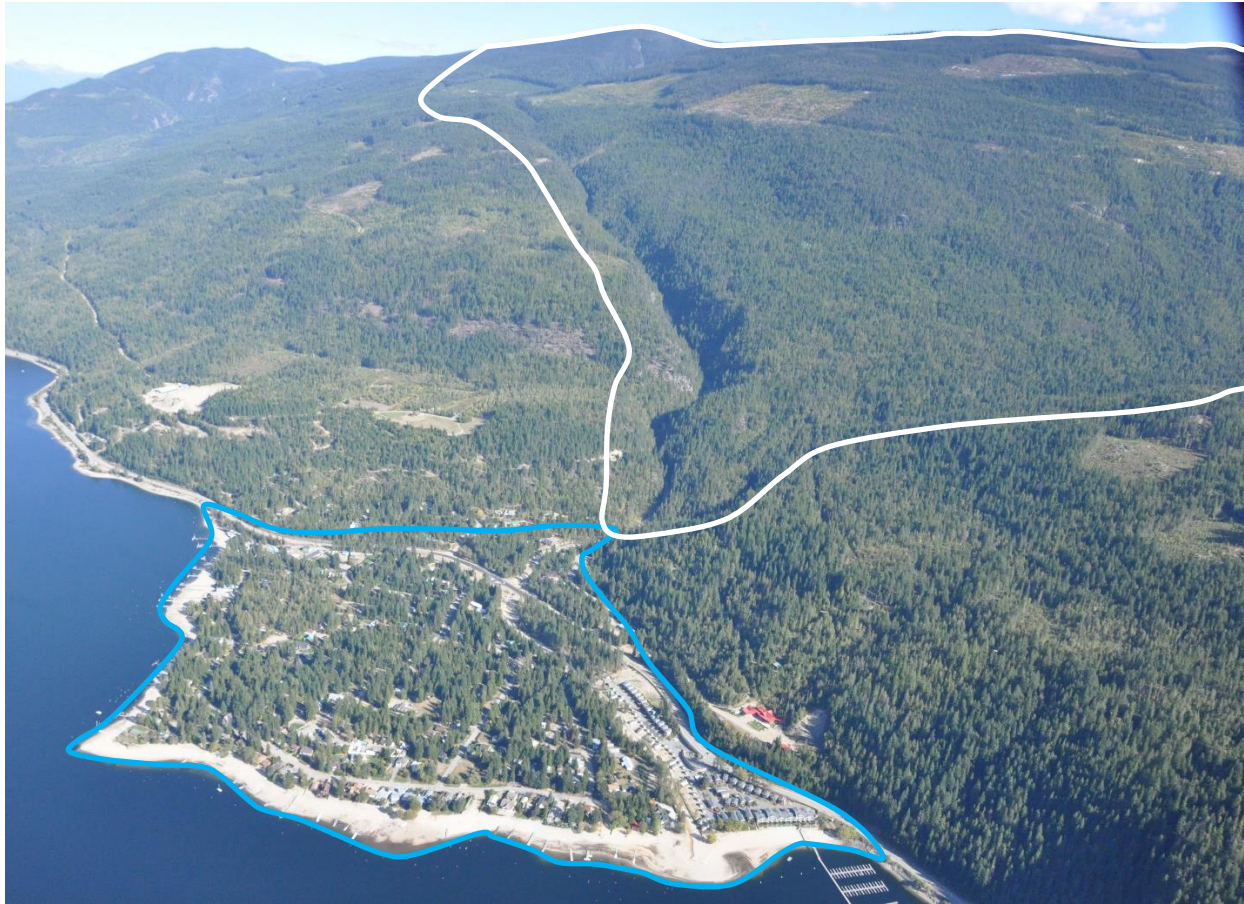
Figure C-2. A typical steep creek watershed and fan (Hummingbird Creek) located near Sicamous in the TRW, with Shuswap Lake in the foreground. The approximate watershed (which extends outside of the margins of the photo) and fan boundary are outlined in white and blue, respectively. Photo: BGC, taken on October 4, 2012.

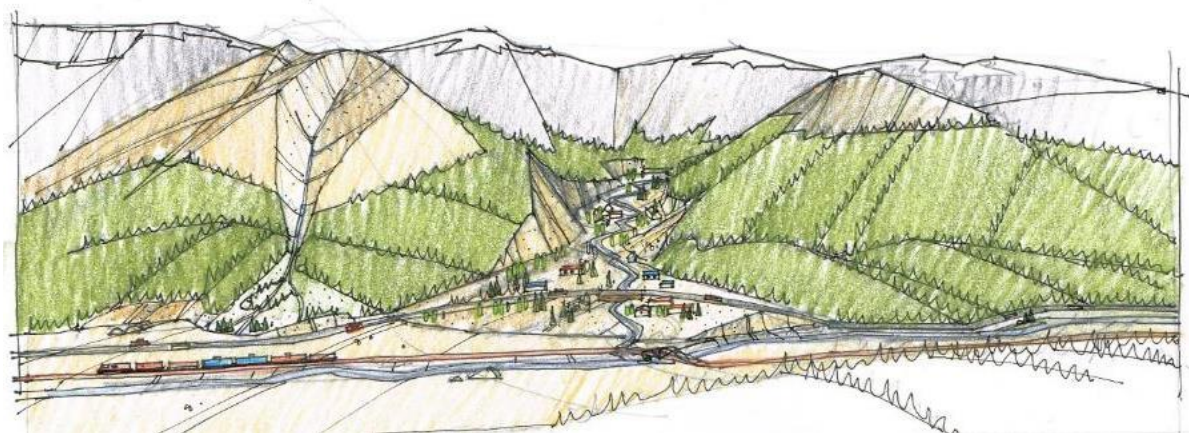
Figure C-3. Typical steep and low-gradient fans feeding into a broader floodplain. On the left a small watershed prone to debris flows has created a steep fan that may also be subject to rock fall processes. On the right a larger watershed prone to debris floods has created a lower gradient fan. Development and infrastructure are shown to illustrate their interaction with steep creek hazard events. Artwork: Derrill Shuttleworth.

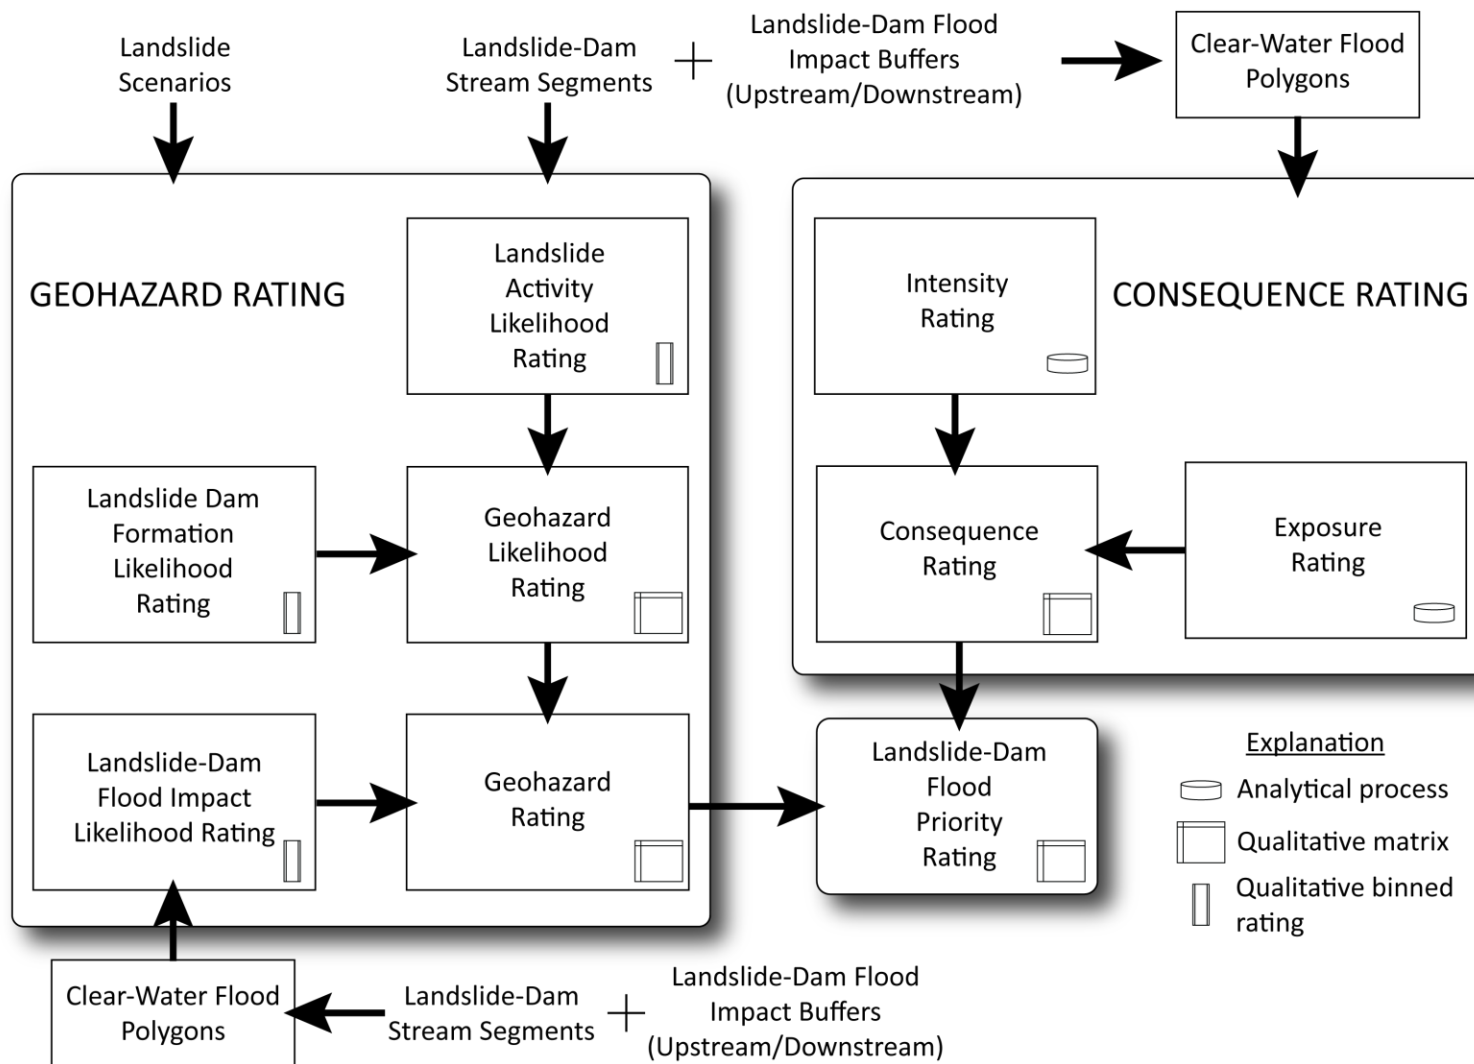
Figure D-5. Landslide-dam flood hazard analysis workflow. Geohazard rating elements are described in Appendix D (this text). Consequence rating elements are described in other sections (Appendix B and C, and Section 5.0 of the Main Report).
